## **Clark Pond, Manchester 2010 - 2011 Report**

Submitted to:  
Massachusetts DER  
Boston, Massachusetts

By  
Barbara Warren  
Salem Sound Coastwatch  
201 Washington Street #9  
Salem MA 01970  
[www.salemsound.org](http://www.salemsound.org)

February 2012

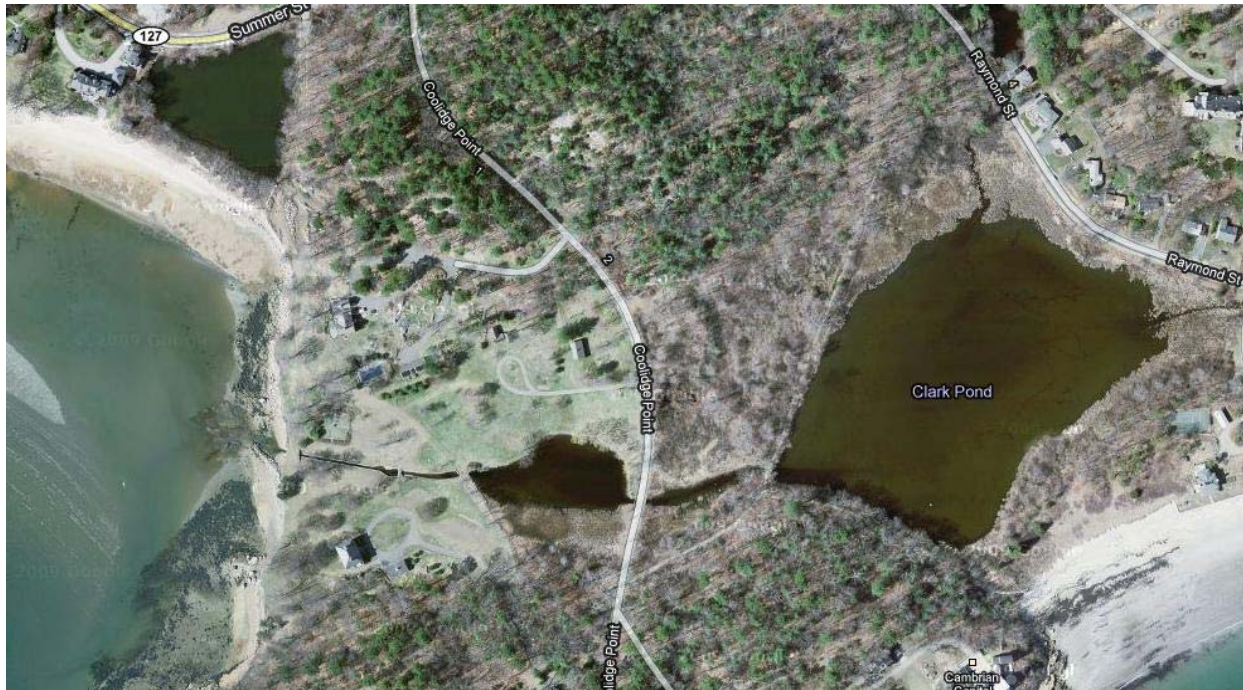
Figure 1. Location of Clark Pond between Kettle Cove (left) and Grey Beach (right)

The replacement of the undersized granite culvert and granite slab footbridge restriction that doubled the channel’s flow capacity from 70 CFS to 150 CFS did not result in salinity changes in and around the pond, during the few months after its replacement. This short post restoration time and the fact that Clark Pond receives water from Kettle Cove via a 1,200-foot tidal channel may be explanations for this lack of change (See Figure 1 (pg 7)).

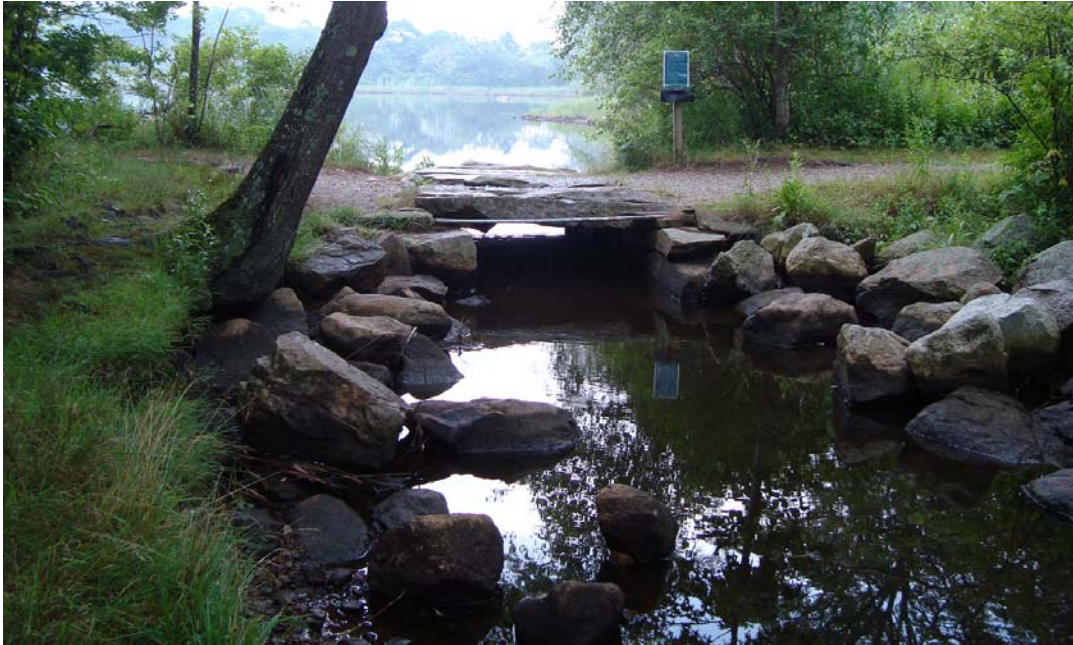
Figure 2. - Pre-construction: culvert and footbridge tidal restriction at Clark Pond

Phase Two, removal of all four restrictions downstream and the replacement of the undersized granite culvert and granite slab footbridge with an open, stone and masonry channel, Phase Three, were completed by May 2011. A wooden footbridge was constructed across the channel to maintain public access to the property. The dimensions of the new channel is 8 feet wide, 2.5 feet wider than the previous 5.5-foot wide channel, and the lower and upper inverts were adjusted

slightly to improve flow characteristics. A doubling of the channel's flow capacity from 70 CFS to 150 CFS is expected. Replacement of the granite slab footbridge with a wooden structure day-lighted seven linear-feet of stream length, as the footbridge width was reduced from its present 17-foot width to 10 feet.

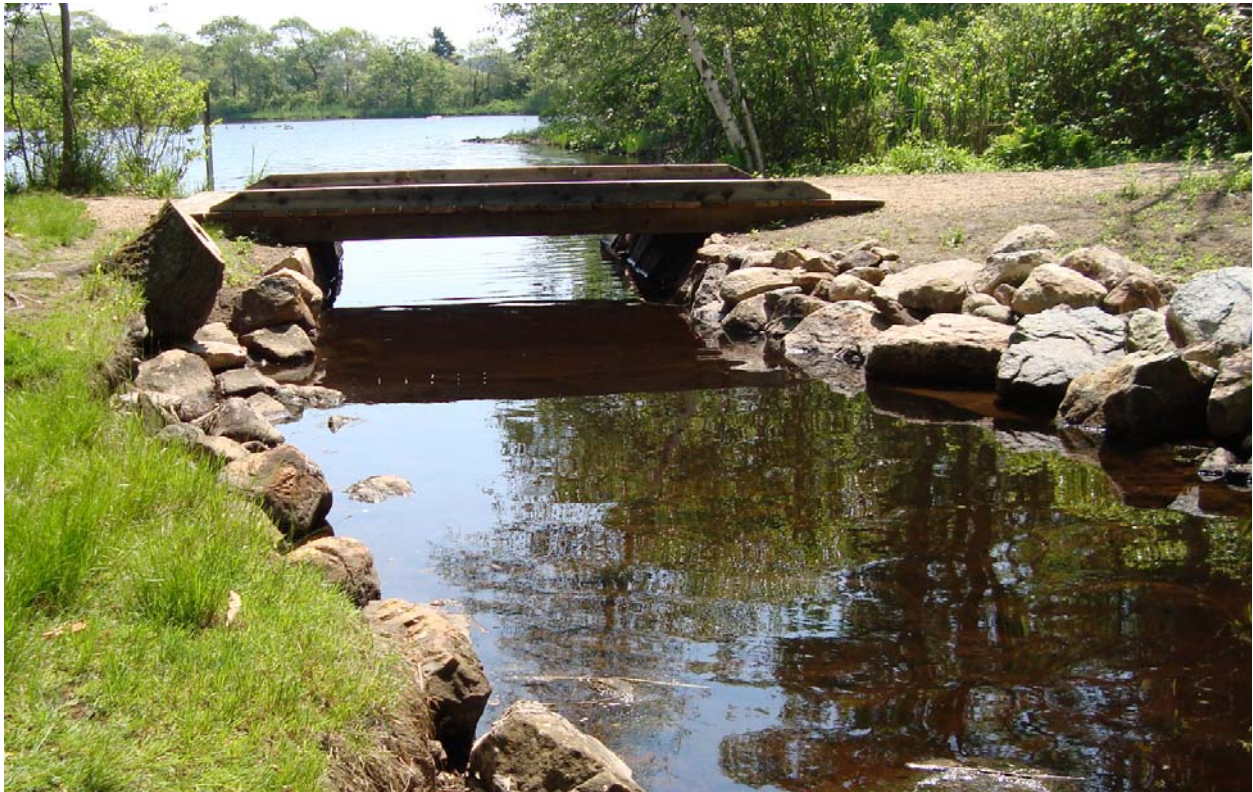
Figure 3. New footbridge replaced in 2011 at Clark Pond

The new footbridge was replaced before post-construction monitoring was conducted from 6/08/2011 through 8/11/2011.

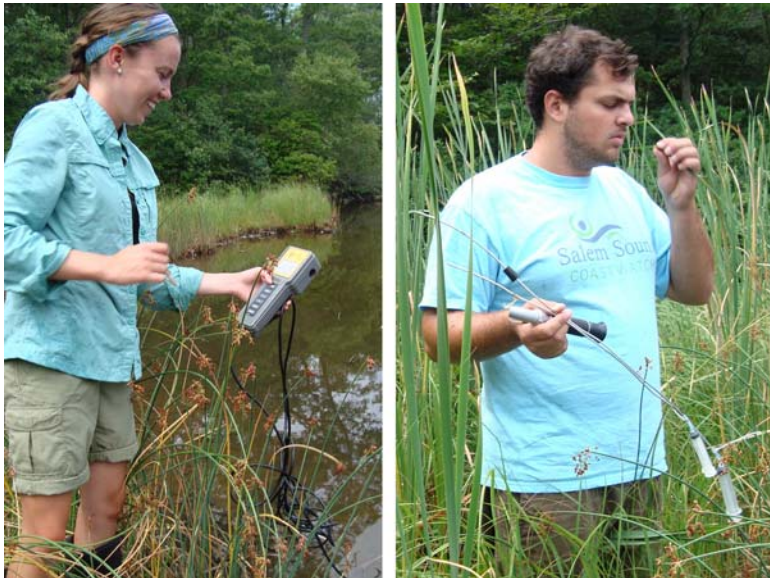
Figure 4.  
SSCW staff measure pond salinity with a YSI (left) and pore salinity with a sipper and refractometer (right).

The water chemistry effort measured ground water salinity at five stations around the edge of Clark Pond as well as water from the pond and creek channel. Sippers were used to collect pore water at Stations 3 through 7 (see Figure 3). A VISTA Series Instruments Portable Refractometer (model number A366ATC (0-10% Sal.) was used to measure salinity when sippers were used. The sensor on the refractometer was rinsed with deionized water and dried between readings. The error of the refractometer used to measure salinity, could be as much as 1.0 ppt. Surface water salinities were measured from the creek channel (Station 1) and the pond (Station 2) using a YSI 30 in 2010 which measures salinity, conductivity and temperature. In 2011 all measurements were taken with a refractometer.

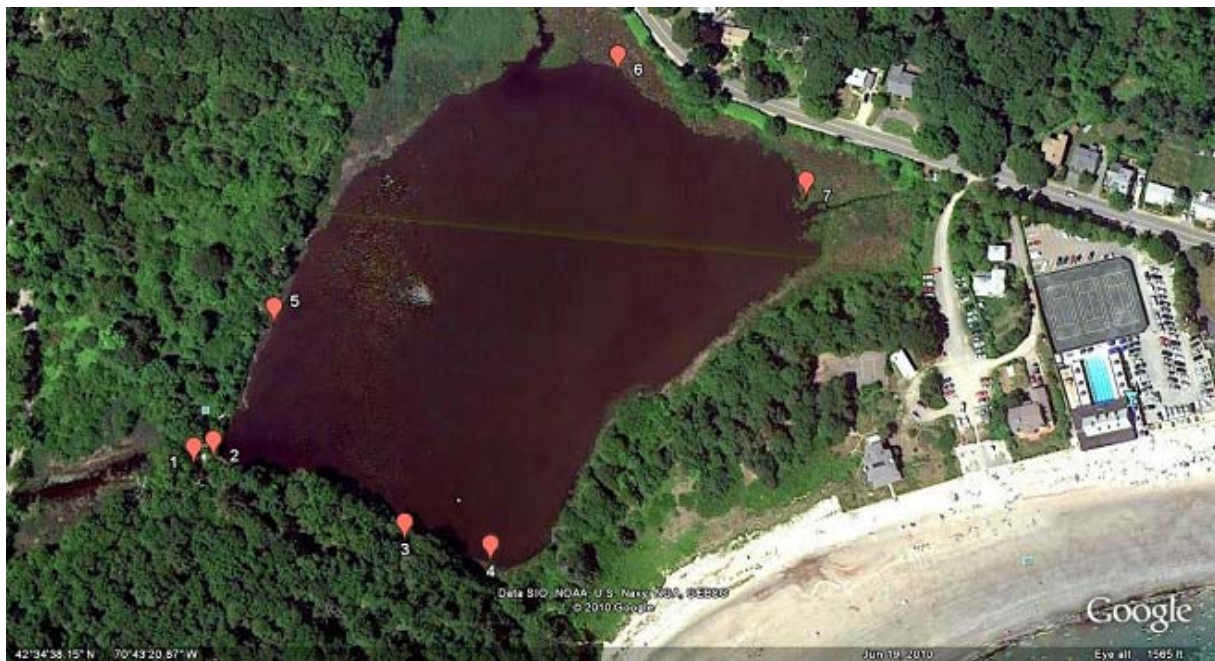
- STATION 1:** Channel water. Salinity data collected during nekton survey
- STATION 2:** Pond side of culvert
- STATION 3:** Fringe marsh south of culvert. Sipper and pond
- STATION 4:** Marsh by Grey Beach. Sipper
- STATION 5:** Fringe marsh off path north of culvert. Sipper
- STATION 6:** Across from 8 Raymond Rd. Enter at clearing from street. Sipper sample taken at edge of pond
- STATION 7:** 16 Raymond Rd. Enter at clearing from street. Sipper sample taken near edge of pond

Figure 5. Locations of salinity measurements at Clark Pond in summer of 2010 and 2011

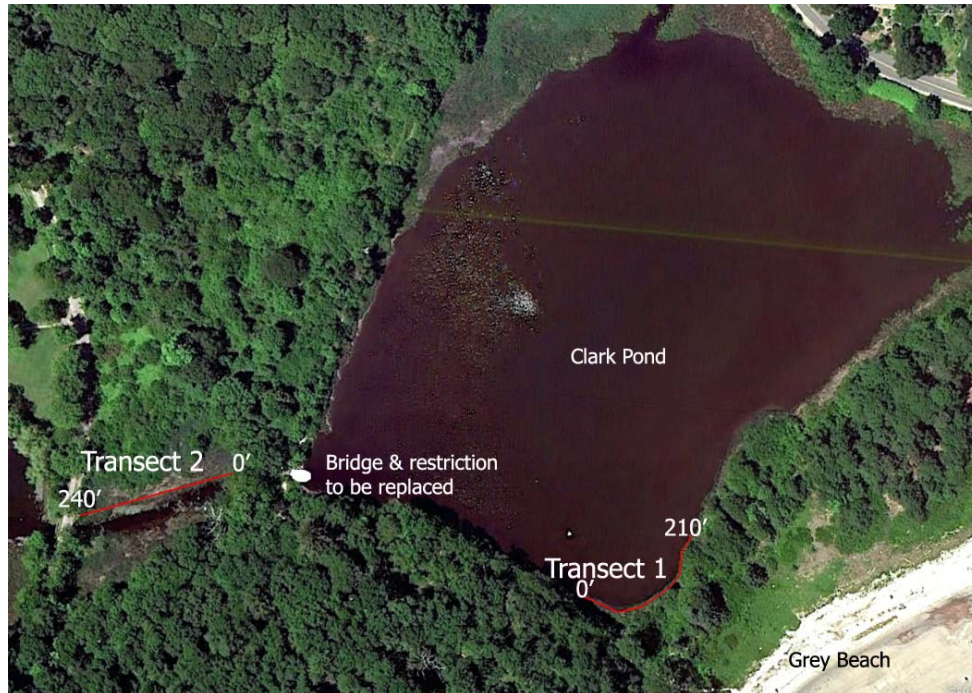
Figure 6. Locations of vegetation transects at Clark Pond in summer of 2010 and 2011.

Since the wetland edge of Clark Pond is, in general, a narrow fringing marsh, Transect 1 was established parallel to the pond edge one meter in from the water. There are larger wetland areas on the northern section of the pond edge, but these are dominated by *Phragmites australis* and difficult to access because of the dense growth. Transect 2 measured the *Phragmites* along the northern side of the creek channel downstream of the restriction created by the granite culvert and granite slab footbridge.

Vegetation monitoring methods used a meter<sup>2</sup> plot frame constructed from ½ inch PVC material, which was placed every 30 feet along each transect. Vegetation Transect 1 ran 140° for plots at 0, 30 and 60 feet; then 70° for the remainder of the plots. Vegetation Transect 2 ran parallel with the creek channel on the north side from 0 feet to 240 feet (the driveway is at 250 feet). Vegetation monitoring within each plot consisted of species presence / absence, percent cover, and height of 10 tallest *Phragmites australis* stems where applicable. Vegetation sampling took place in September in 2010 and August in 2011. All plants were surveyed on the same day. Transects were run one meter in from water's edge; then plot frame was placed between the

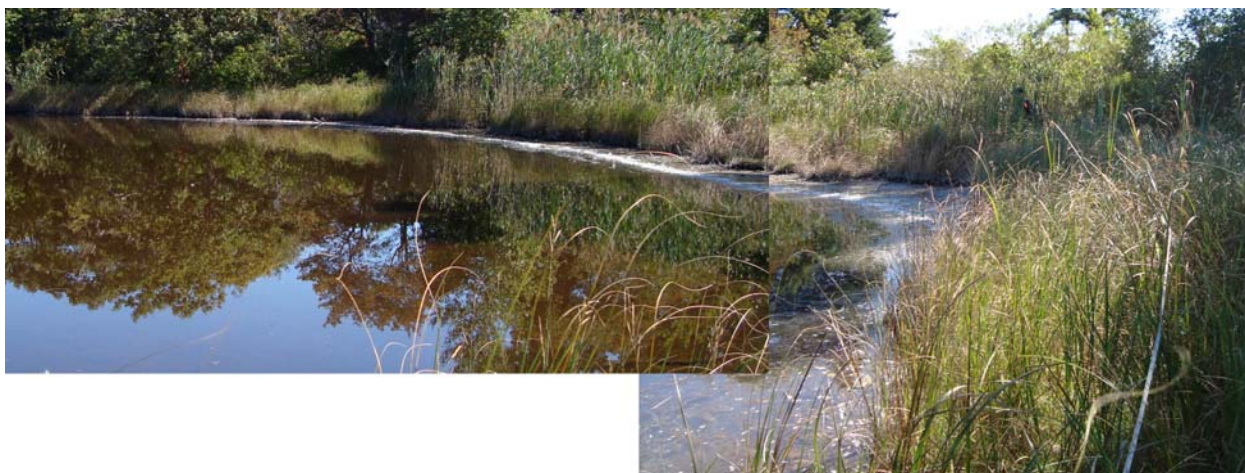
Figure 7. Vegetation Transect 1 at Clark Pond, summer of 2010 and 2011

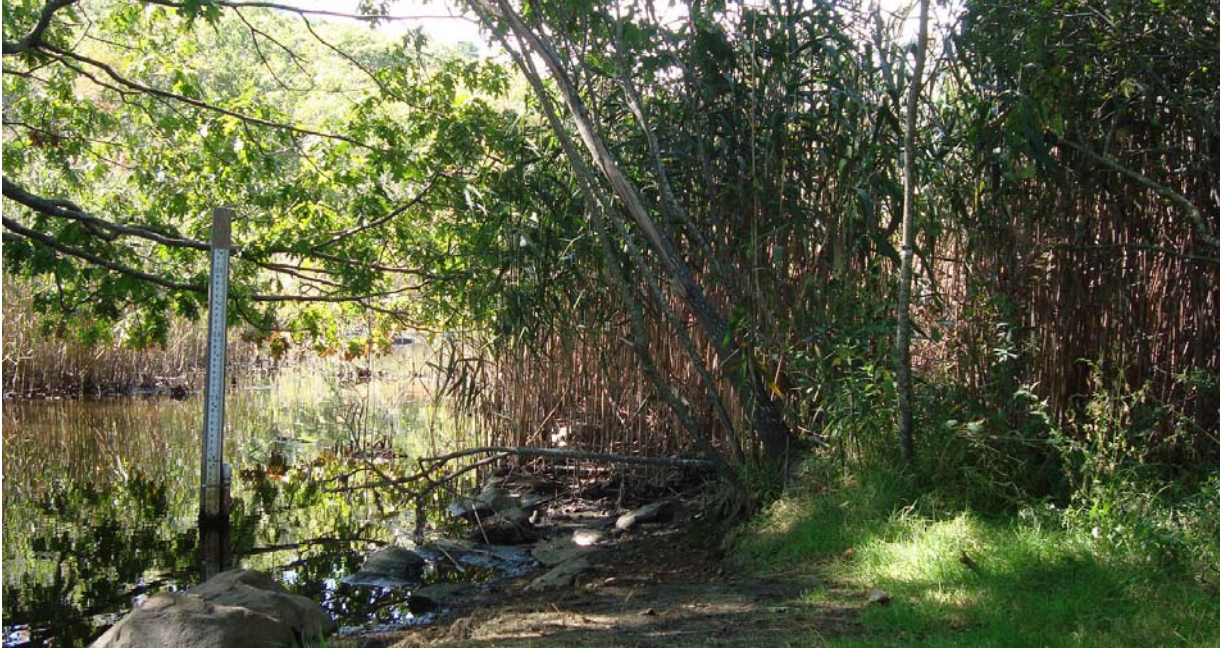
Figure 8. Vegetation Transect 2 at Clark Pond outlet creek channel, summer of 2010 and 2011. Transect begins at the edge of the *Phragmites australis* and runs 240 feet westerly to the driveway.

The vegetation transect sampled along the north side of the tidal channel between the footbridge and the driveway was dominated by *Phragmites* as evidenced by the 59% coverage in 2010. The increase in “Other” in 2011 and the decrease in percent coverage of *Phragmites* may be indicative of a trend that is worth further study. There was a definite increase in bare ground, standing water and dead cover consisting primarily of *Phragmites* stalks in August 2011.

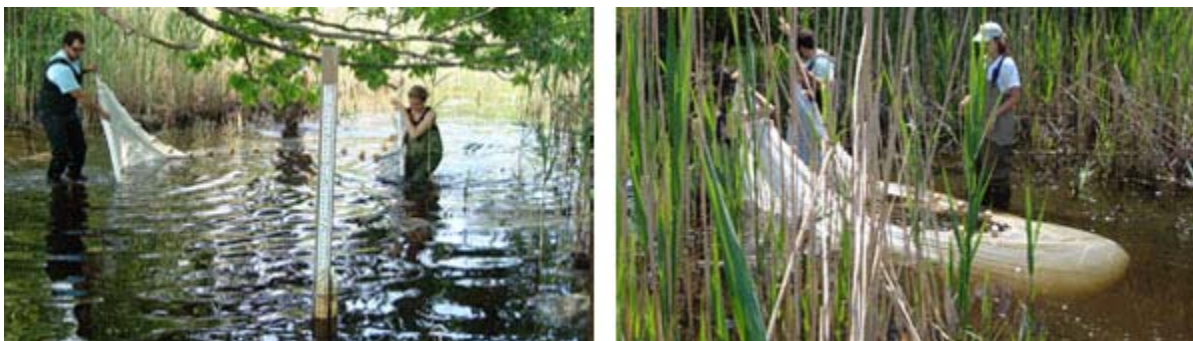
Figure 9. SSCW staff and summer interns prepare to seine the creek channel for nektons

A seine was borrowed from Mass Audubon's Wenham office the first year and then DER funds were used to purchase the seining net seen in Figure 9. Seining on three sampling dates per summer collected nektons. The samplers walked down the path through the *Phragmites* approximately 100 feet. The net was stretched across the stream and pulled upstream into the current. Samplers worked to keep the weighted net bottom on the stream substrate, but conditions were not ideal since the substrate was mucky and littered with sticks, branches and rocks. The net was pulled out just upstream of the channel tide gauge staff shown in Figure 10.

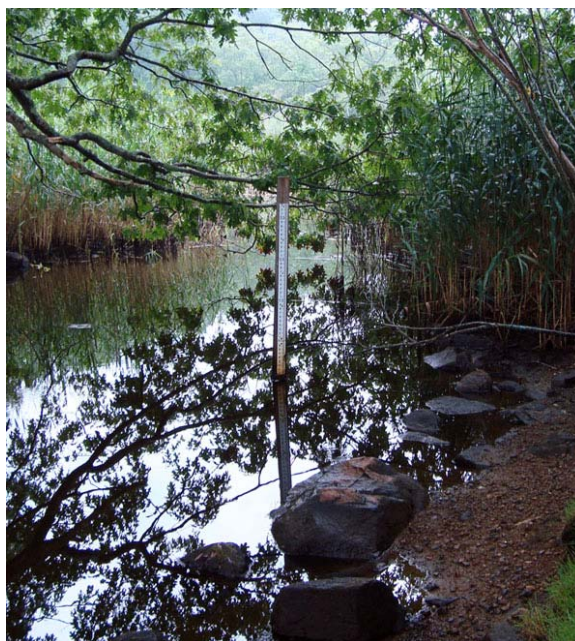
Figure 10. Tide gauge and exit location of seine

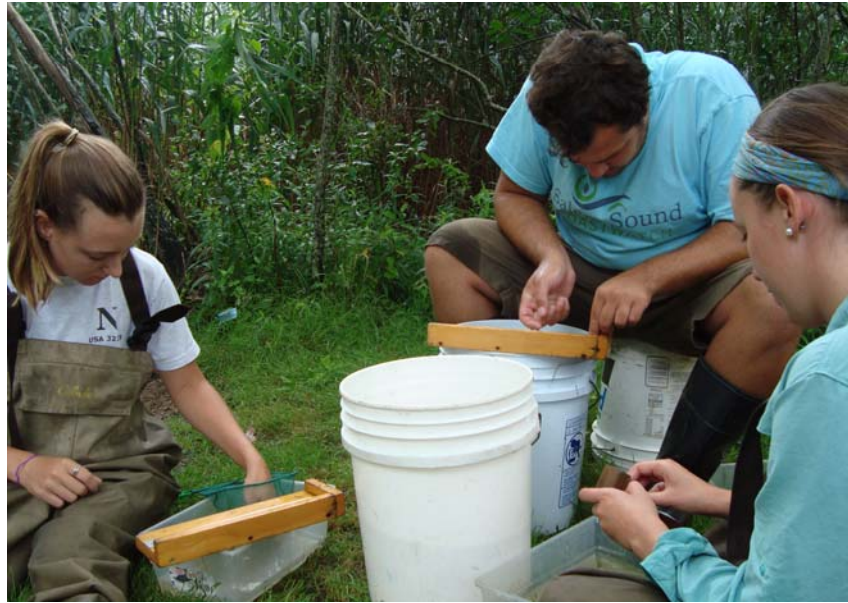
Figure 11. Measuring length of the first 40 fish of a species

Steps outlined in A Volunteer's Handbook for Monitoring New England Salt Marshes were followed. Nektons were identified to species and counted. If more than 40 individuals of any particular species were collected, a sub-sample of 40 individuals was randomly sampled. A small net was used to capture fish from the bucket containing the entire individual species catch. The length of the first 40 of each species was measured to the nearest millimeter and then the 40 were weighed to the nearest gram to determine the aggregate weight. Any external abnormalities, such as skin lesions or parasites were noted. The remaining fishes of a species were counted and weighed. All were returned to the water as soon as possible to avoid mortality.

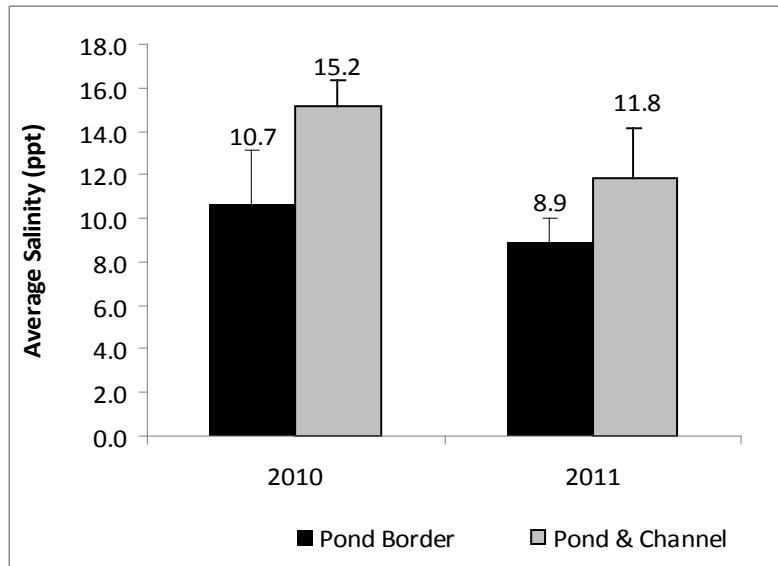
Figure 12 - Annual pore water salinity averaged across depths for 2010 pre-restoration and 2011 post restoration compared to salinity readings averaged from the pond and outflow channel at the footbridge. Bars represent means  $\pm$  SE.

Pore water salinity was lower than the salinity of the pond or outlet channel for both years of monitoring. The replacement of the footbridge, which enlarged the Clark Pond outlet, did not result in an immediate rise in salinity. In fact, salinity readings in both the pore water and the pond and channel were lower in the post-restoration year.

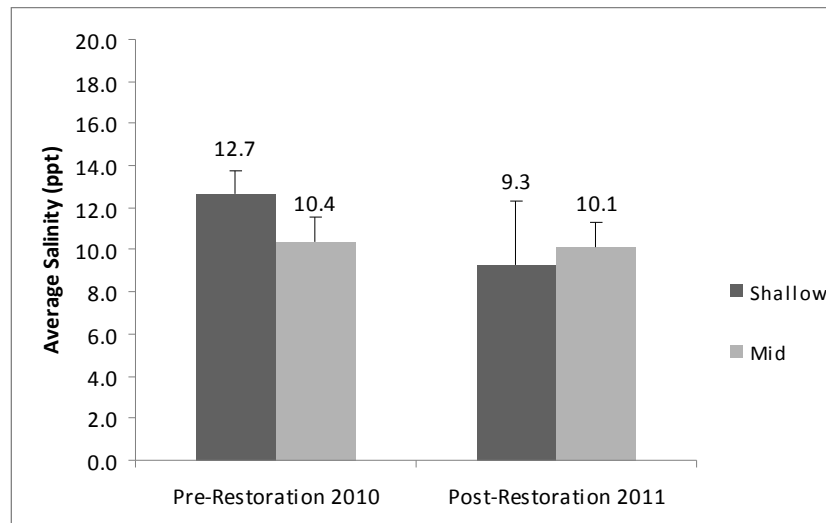
Figure 13 – Pore water salinity across Clark Pond wetland border (pre restoration and post restoration) and depth (shallow and mid). Bars represent means  $\pm$  SE.

Pore water salinity was further analyzed across depth for the one year of pre restoration and one year of post-restoration data. No trend was discernible between depth and pre restoration vs. post restoration. Readings for August 2011 were not used (Table 1 \*) because of quality control issues. Salinity readings were 0 ppt, which were initially believed to be the result of 2-4 inches of rainfall, but when the refractometer was retested back at the office, it was found to be defective.

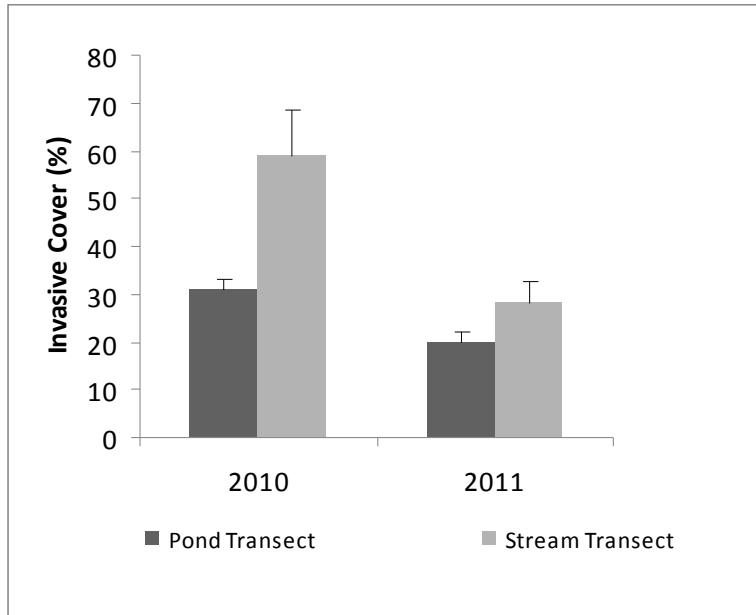
Figure 15 – Annual invasive plant cover (%) grouped by transects for each year.

The only invasive plant found in the two transects in 2010 was *Phragmites australis*. In 2011, *Lythrum salicaria* (purple loosestrife) was also found either as single plants or small groupings along the pond edge, but nowhere did it dominant or cover extensive areas. In contrast, where *Phragmites* was present, it dominated. The abundance of *Phragmites* in both transects decreased from 2010 to 2011, but more monitoring will be needed before any conclusion can be drawn about its possible decline (Table 4). *Phragmites* height was slightly higher in 2011 at both transects.

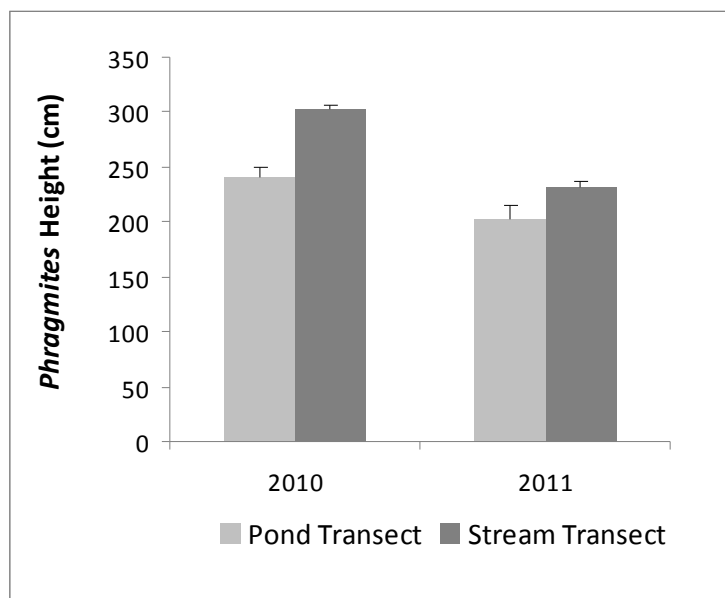
Figure 16 – Annual *Phragmites australis* plant height (cm) grouped by transects for each year.
