SALEM SOUND COASTWATCH

Salem Sound Clean Beaches and Streams Program Report for June through August, 2017

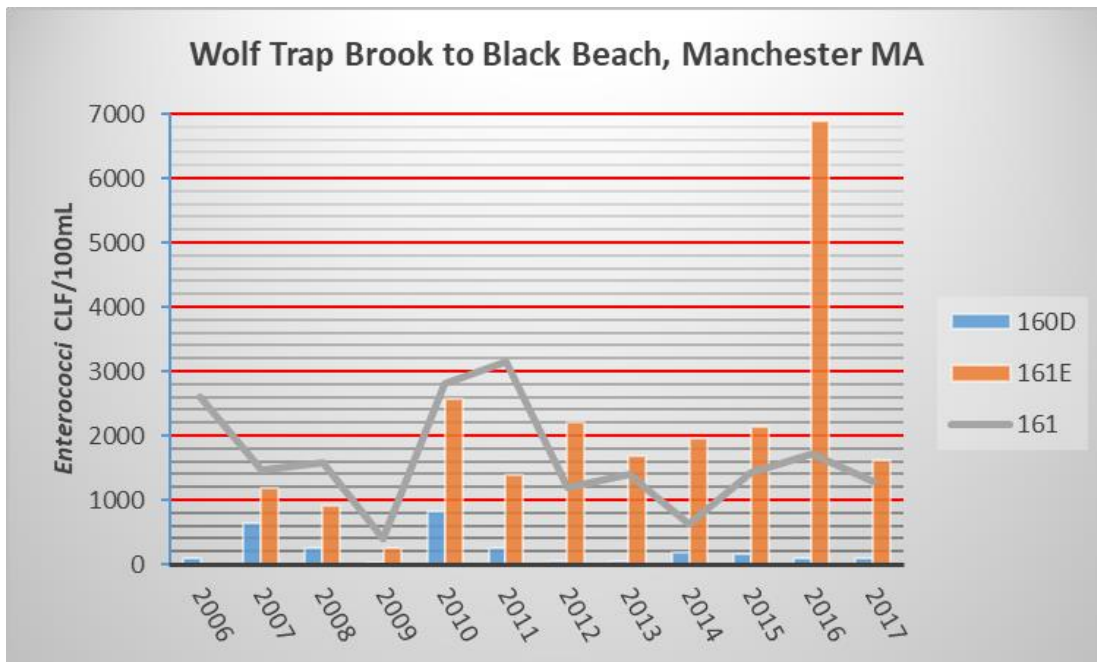
Figure 1. Geometric Mean of Bacterial Counts For All Sampling Events (Wet and Dry) from 2006 - 2017

Year / Site #	160D	161E	161
2006	99	1,186	2,606
2007	632	920	1,476
2008	252	258	1,590
2009	26	258	407
2010	826	2,565	2,811
2011	246	1,384	3,144
2012	52	2,208	1,200
2013	48	1,684	1,407
2014	173	1,958	632
2015	151	2,130	1,430
2016	96	6,897	1,707
2017	82	1,606	1,276

Starting in 2012, the water sampled at the footbridge in the middle of the marsh (#161E) had higher geometric means than upstream before the marsh (#160D) or downstream at the ocean (#161).

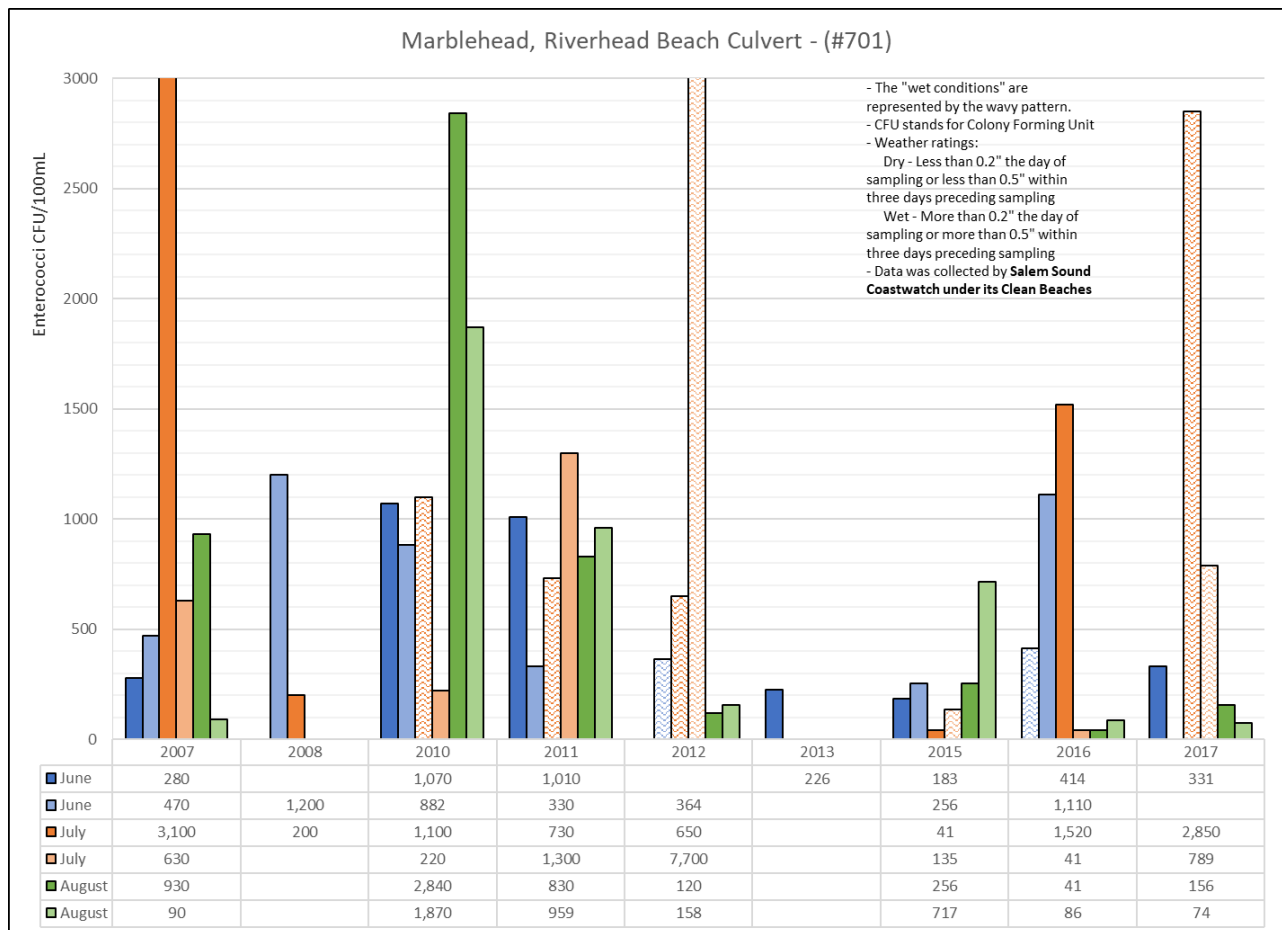
Figure 2. Graphic representation of Enterococcus results at Marblehead’s Riverhead Beach Culvert 2007 to 2017.

In 2015 and 2016, SSCW returned to the Riverhead Beach culvert (#701) which drains much of the downtown area and the neighborhood around the Goldthwait salt marsh after the Marblehead Water and Sewer Commission completed a large stormwater project in the downtown area, 2013 – 2014. The chart below shows a decrease in bacterial levels since this effort was made, except for rain events.

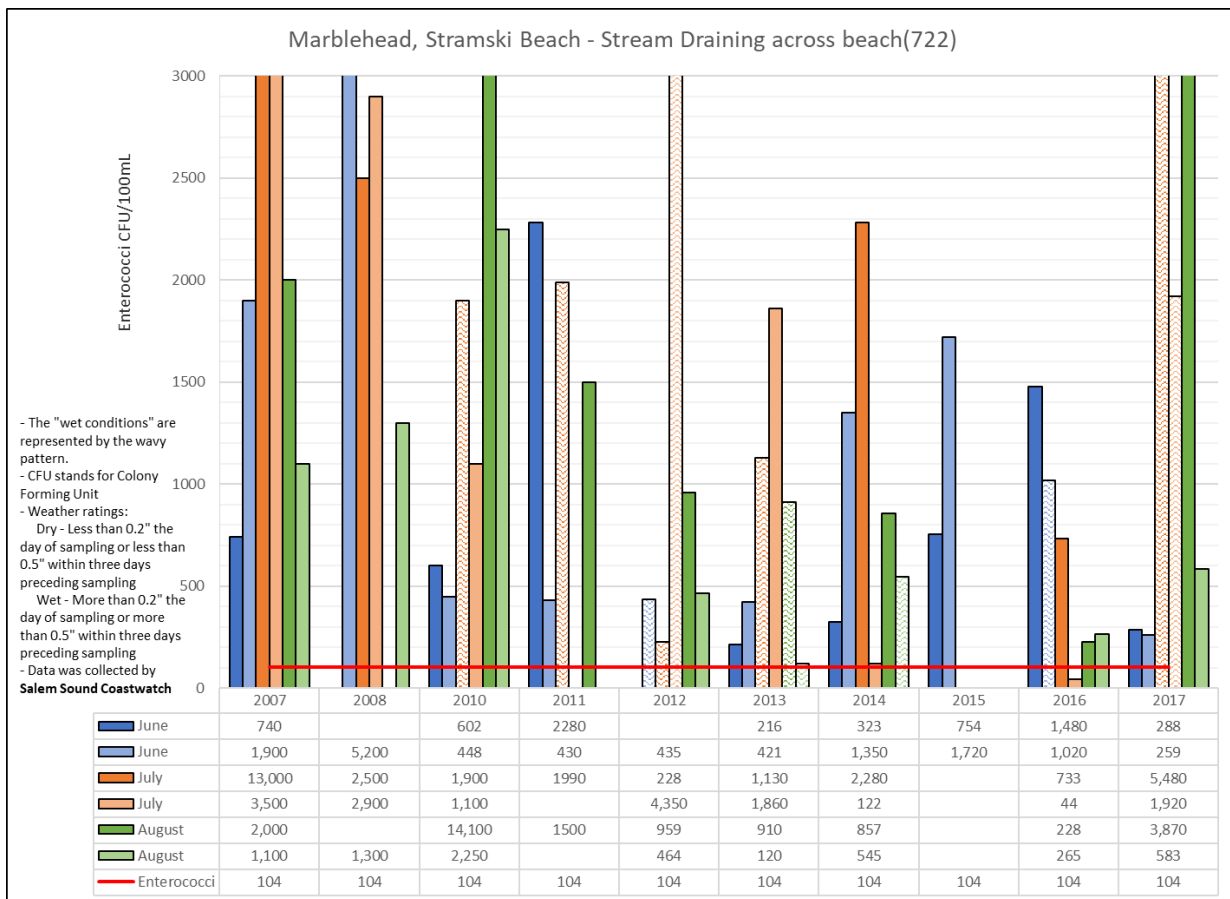
Figure 3. Graphic representation of Enterococcus results at Marblehead’s Stramski Beach Culvert 2007 to 2017.

The stream flowing onto Stramski Beach (#722) has been a trouble spot for many years. From 2003 to 2011, the beach was closed due to contamination fifteen times; with 53% (8 times) of the closures associated with rain events. In 2007, working with Salem Sound Coastwatch, the Marblehead Water and Sewer Department inspected the stormwater infrastructure in this watershed. Storm drains were cleaned and sampled. It was

concluded at that time that the presence of raccoons and the low flow, which creates stagnant conditions, may be contributing factors to this persistent watershed problem. Sampling was not conducted in 2015 or 2016, because of the SESD sewerage pipe replacement project in Salem Harbor. Sampling began again in 2017.

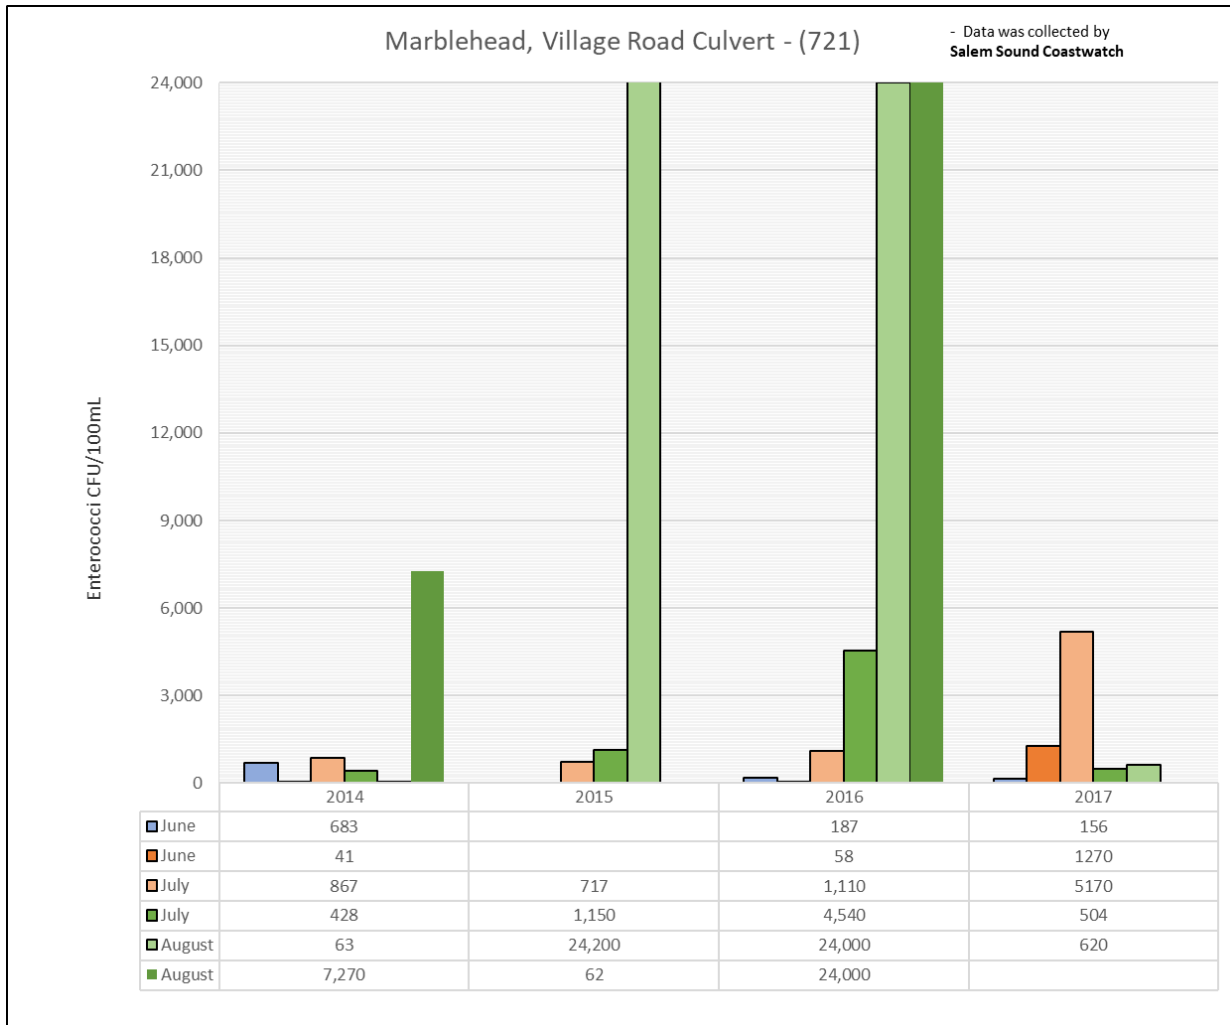
Figure 4. Graphic representation of Enterococcus results at Marblehead’s Village Street Culvert 2014 to 2017.

Village Road culvert (#721) was added to the Marblehead outfalls being monitored in 2014. In 2015, the culvert was sampled only in July and August - with a bacterial spike in August. In 2016, the high exceedances were seen again in August with bacteria levels > 24,000 CFU/100 mL (not wet weather).

Salem Sound Coastwatch spoke with the Marblehead Water and Sewer Department suggesting an investigation of the outfall’s watershed. They cleaned the catch basins during the summer of 2017 and found raccoons living in one of them. Dog waste bags in the catch basins is another neighborhood problem. Salem Sound Coastwatch continues to work with Marblehead with public education and monitoring.
