Salem Sound Clean Beaches and Streams Program Report for Manchester-by-the-Sea June through August 2023

The following report is a summary of results from water quality testing that took place from June through August in Salem Sound Coastwatch's Clean Beaches and Streams Program at coastal outfall pipes and streams. Salem Sound Coastwatch (SSCW) conducts water sampling following a Department of Environmental Protection approved Quality Assurance Project Plan (QAPP) that was last revised in 2020. All SSCW volunteer water samplers took the required training as spelled out in this QAPP. Sampling and chain of custody protocols were followed, and a completeness range of 90 to 100 percent of the samples for collection was met.

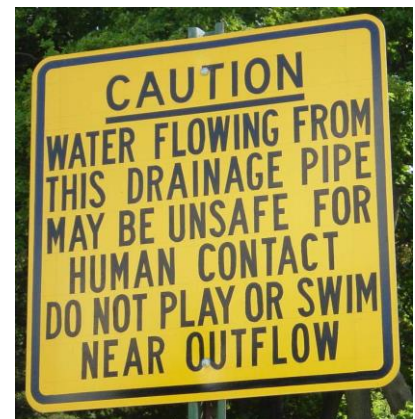
There was one Wet event on July 5, 2023. On this date, every site had bacterial counts above the EPA standard: *Enterococcus* >104 CFU/100mL. The Wet weather results ranged from 119 to 12,098 CFU/100mL. Dry weather sampling ranged from <10 to 24,196 CFU/100mL

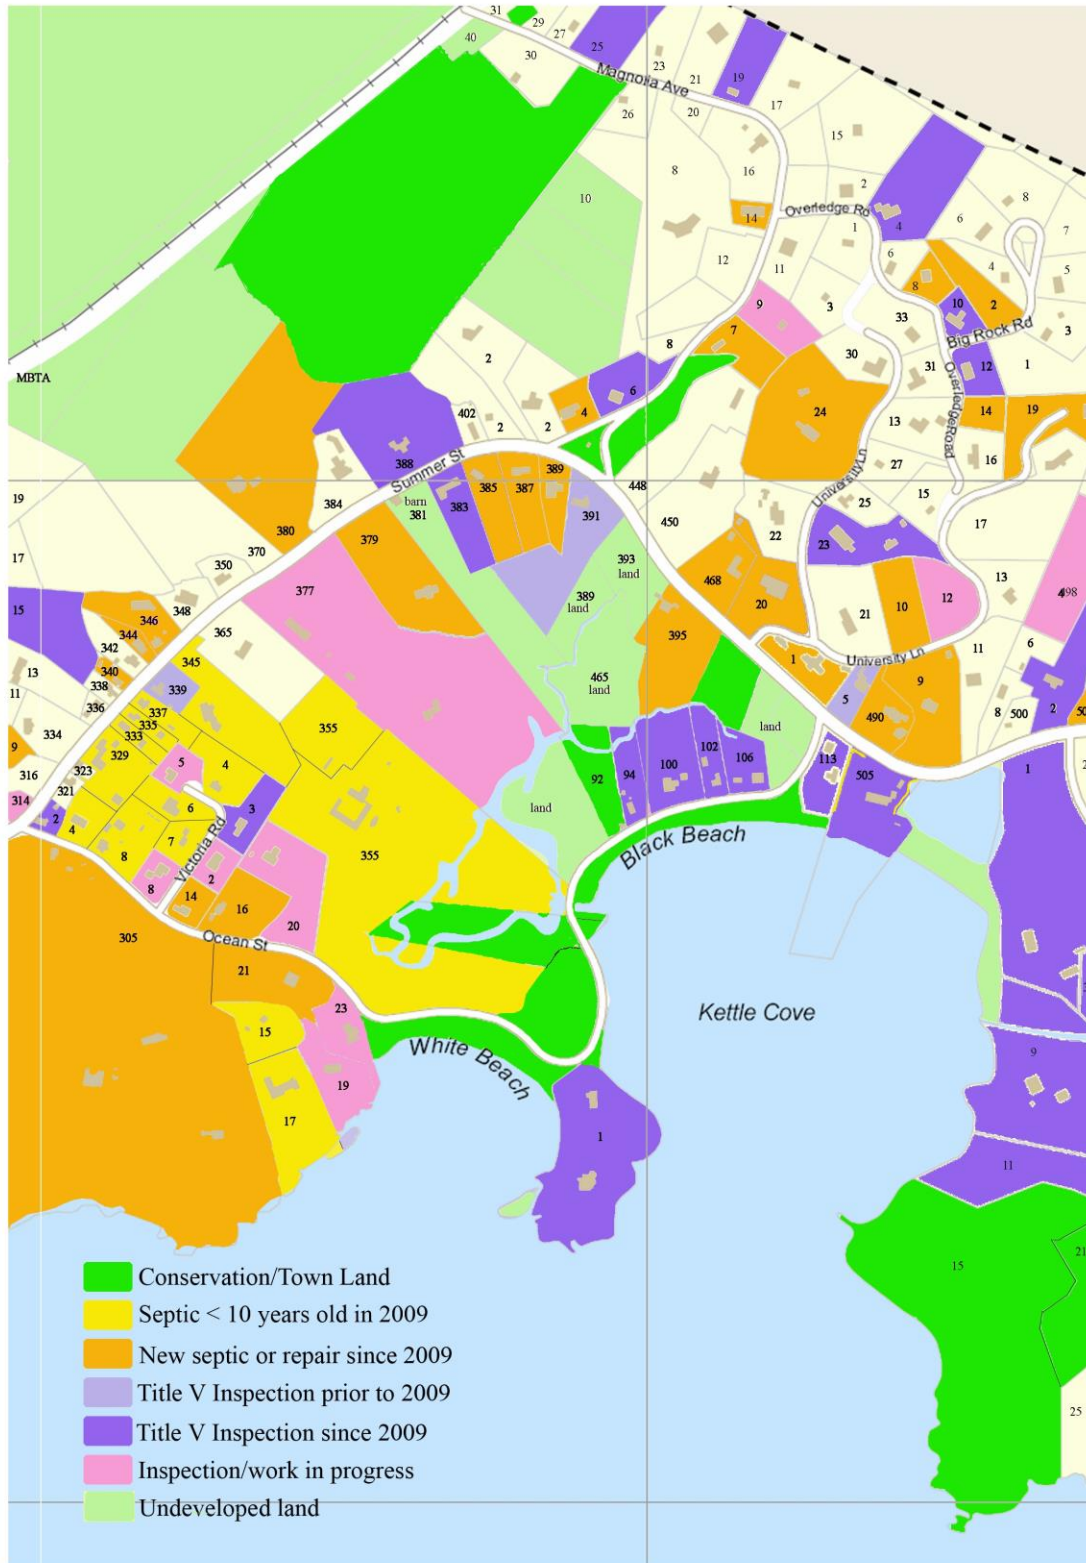
Figure 1: Map of Kettle Cove Septic Systems January 2015 from the Board of Health

Failing septic systems in the watershed were considered a possible source of bacterial contamination as well as the presence of wildlife and pet feces being washed into the brooks during rain events. Because the Wolf Trap estuary has 68 septic systems in its immediate watershed and Title V only requires testing of septic systems on sale of property, in spring of 2009, Town Meeting passed the following action:
