SALEM SOUND COASTWATCH

Salem Sound Clean Beaches and Streams Program Report for June through August 2023

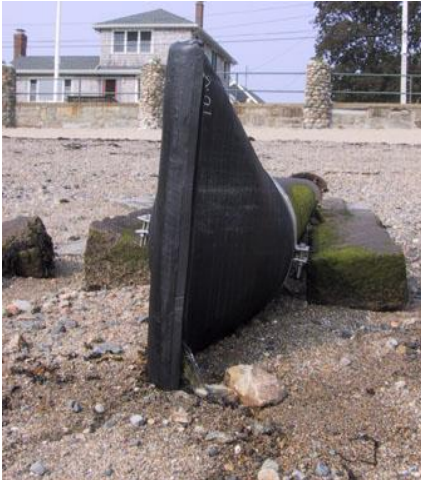
#620 – Juniper Beach, Salem

In 2006, after record-high numbers in 2005 – see Table 8, the Juniper Beach outfall (#620) pipe was cleaned, and a TideFlex “duckbill” tide gate was installed. Bacterial results dropped for several years, but by 2010, bacterial levels had risen to a geometric mean of 7,267 CFU/100mL. The City continued inspections and remediation including the replacement of 100’ of sanitary main line and service laterals. In 2015, an additional 338-foot section of sewer pipe was lined to prevent exfiltration to the drain system and in 2016 approximately 330 feet of sanitary sewer pipe were relined near the Juniper Beach outfall to address indirect discharge. In the Spring of 2023, all the sewer pipes were lined throughout the Willows neighborhood. Sewer manhole covers are scheduled for sealing to prevent contamination next year.

The 2023 geometric mean was 465 CFU/100mL, which removed it from the hotspot list for the eighth year in a row.
